Synkote Paints 14:40 4/3/89

Set A

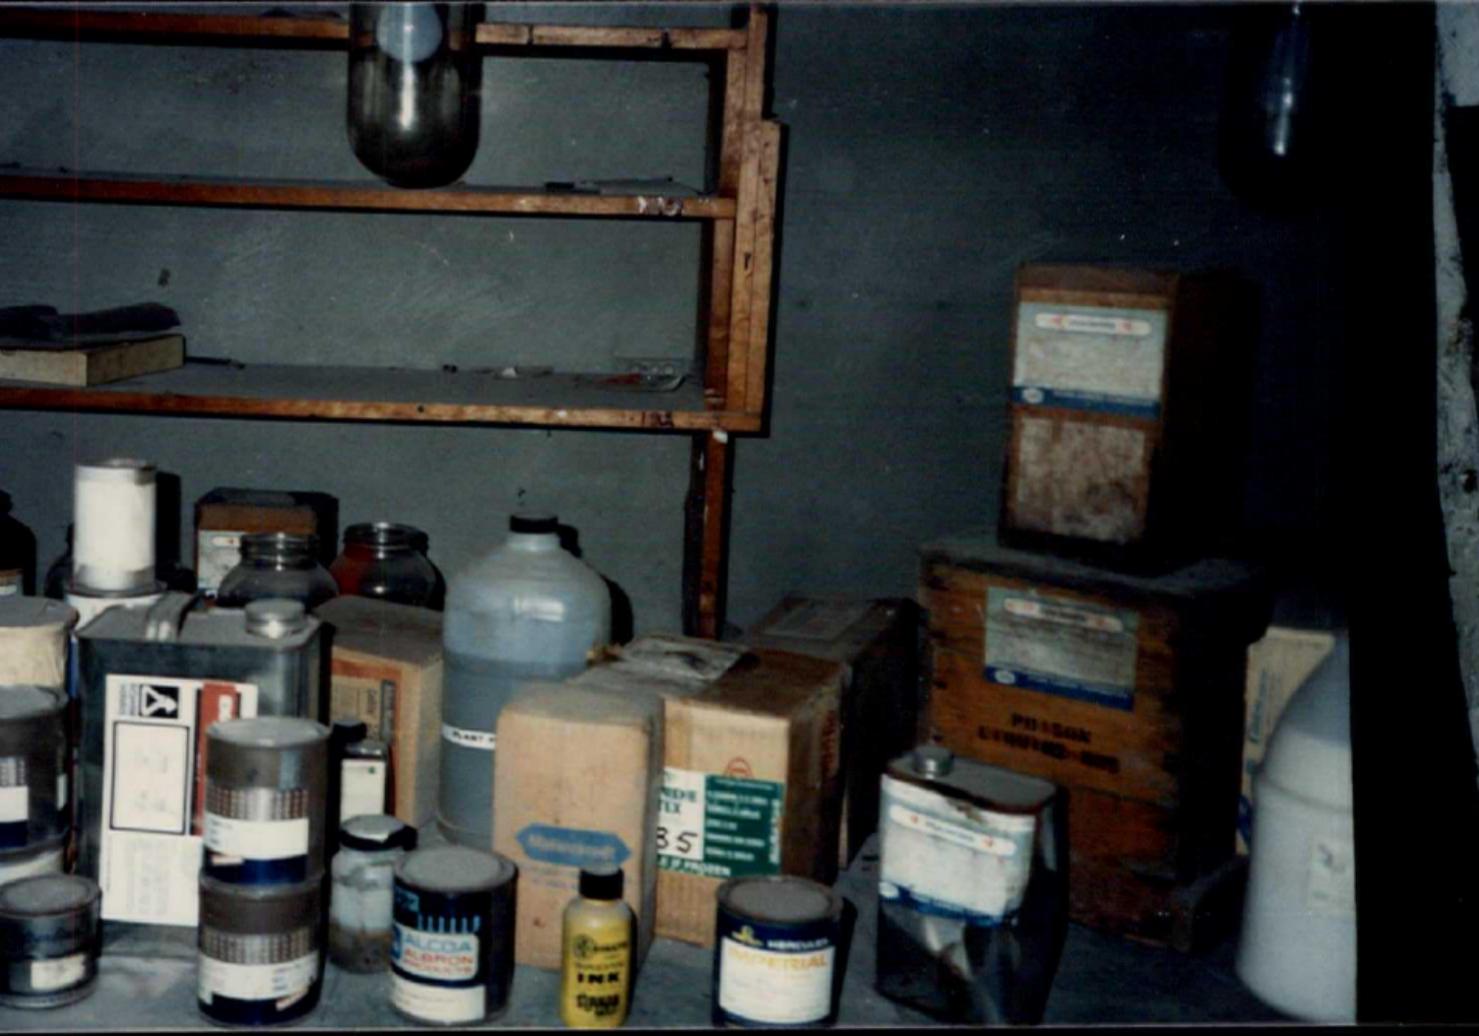
View of center of south lab bench. Note the Poison Liquid NOS container.

This container was labeled epichlorohydrine which is a skin contact poison. This chemical is also incompatible with aluminum. A can of aluminum paste was found near this container to the left.

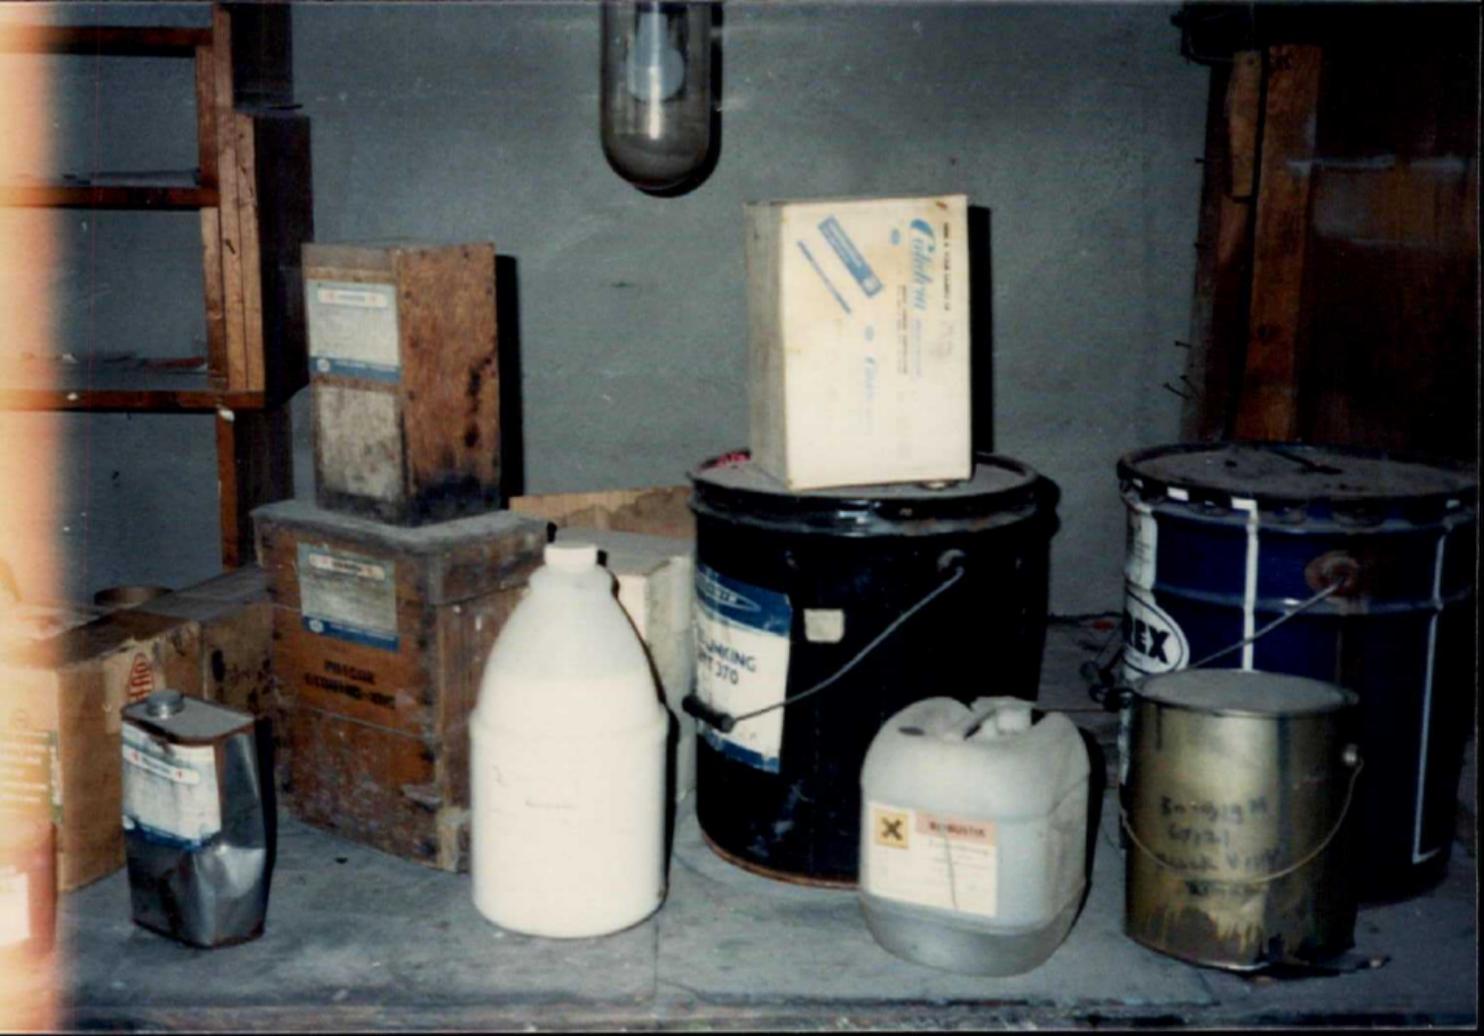
Photo of south end of lab bench
showing various laboratory containers.

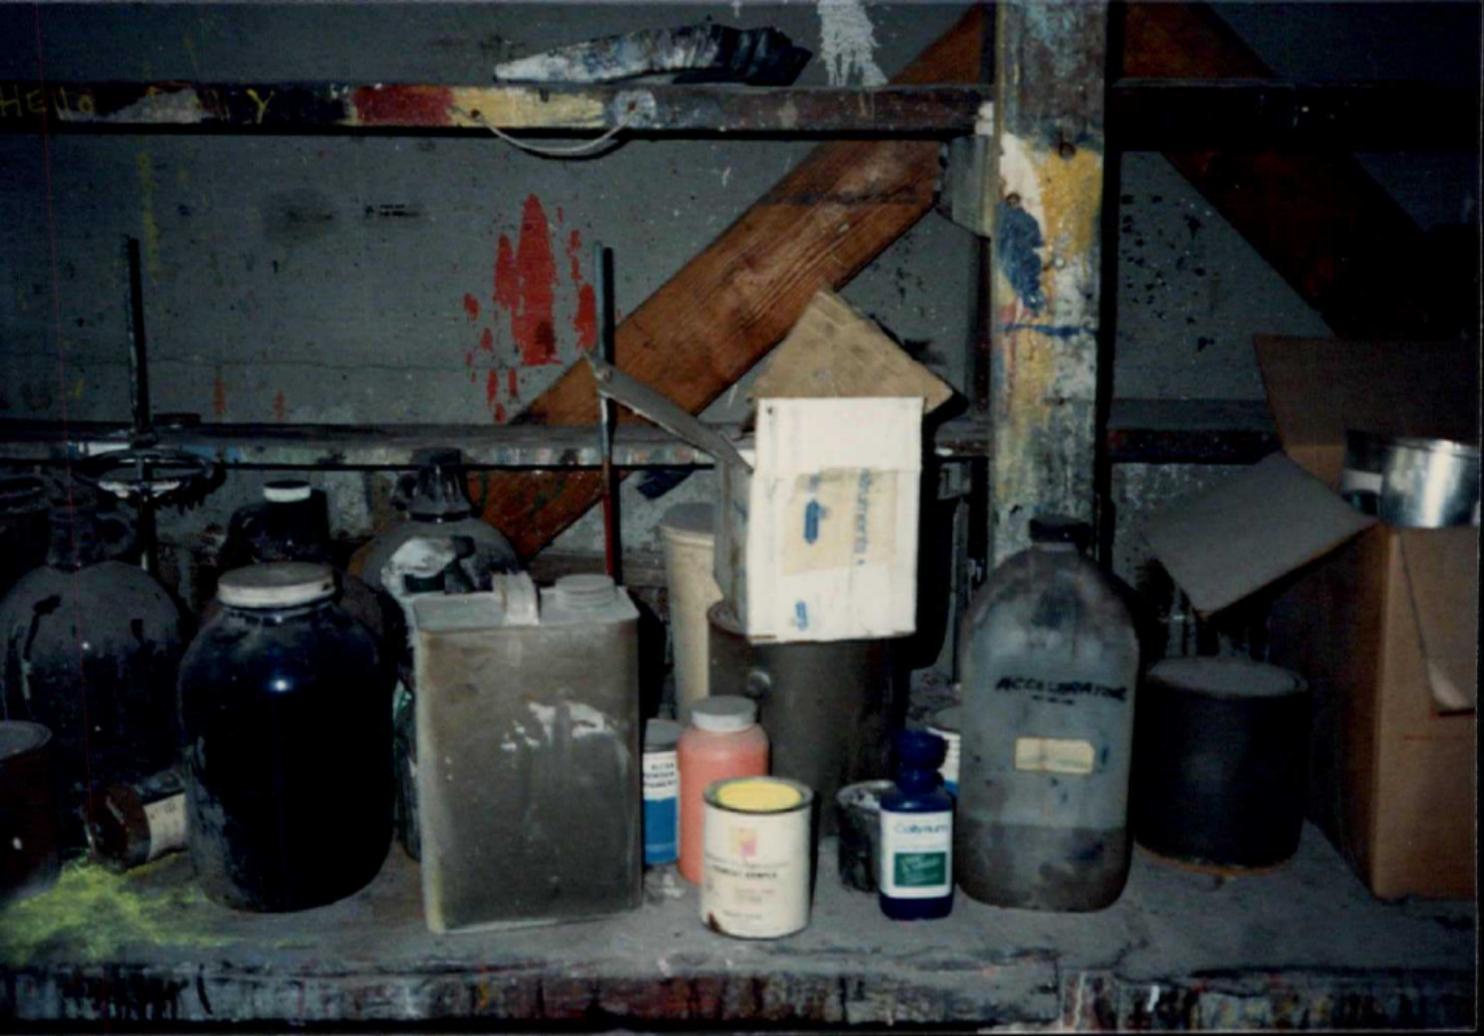
View of North lab bench with
unlabeled containers.

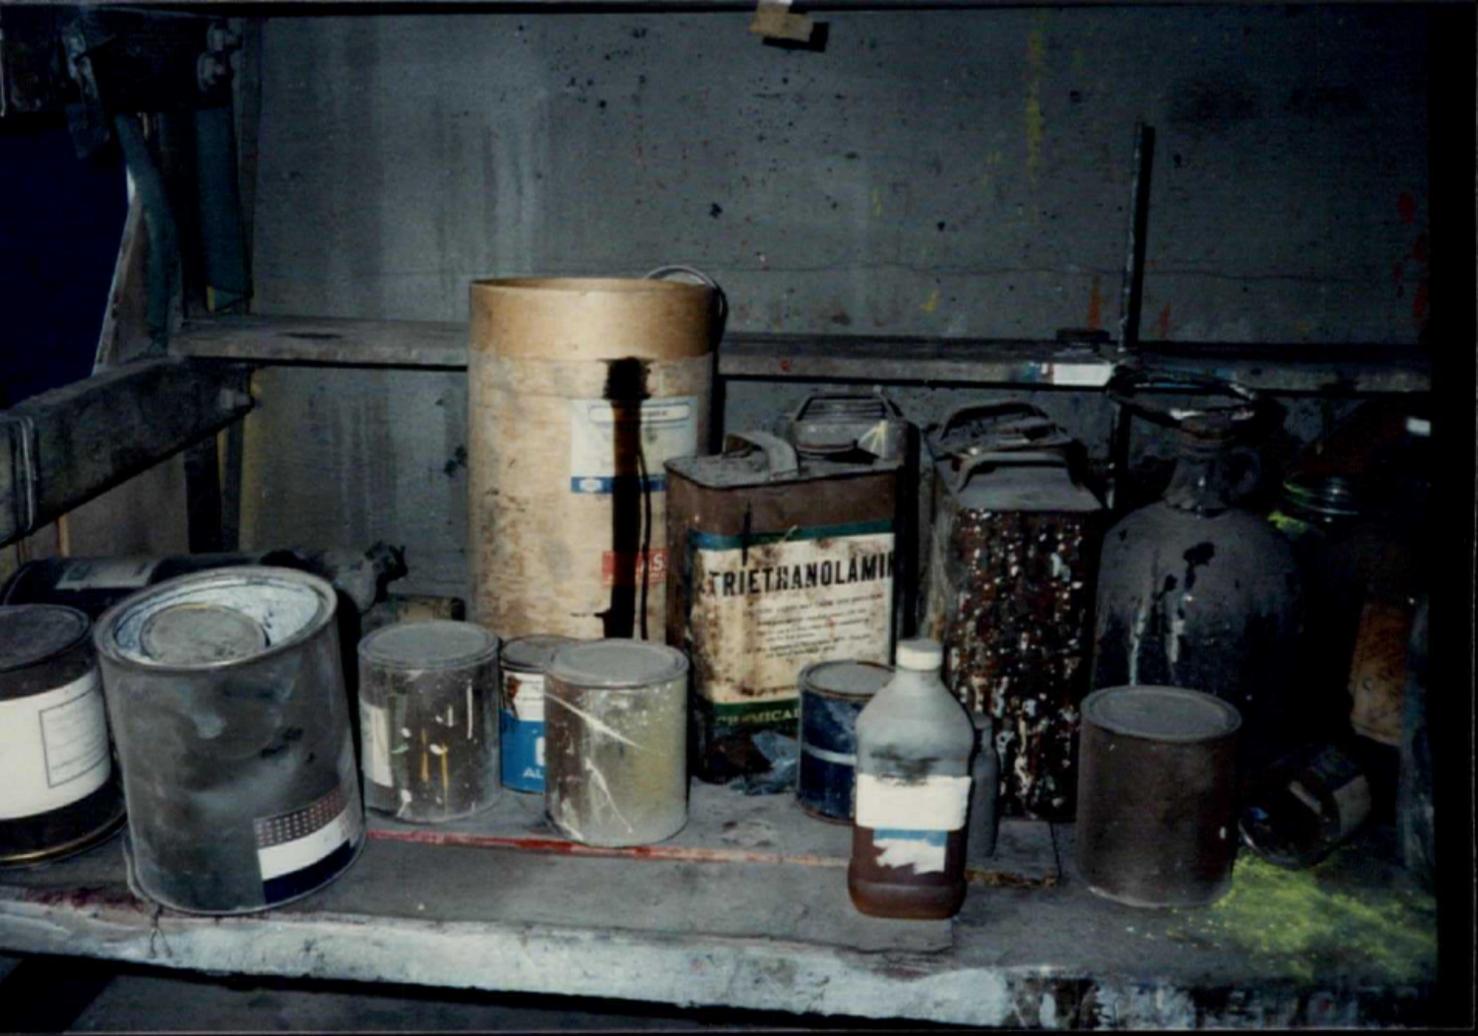
Photo of north lab bench showing
two open containers.

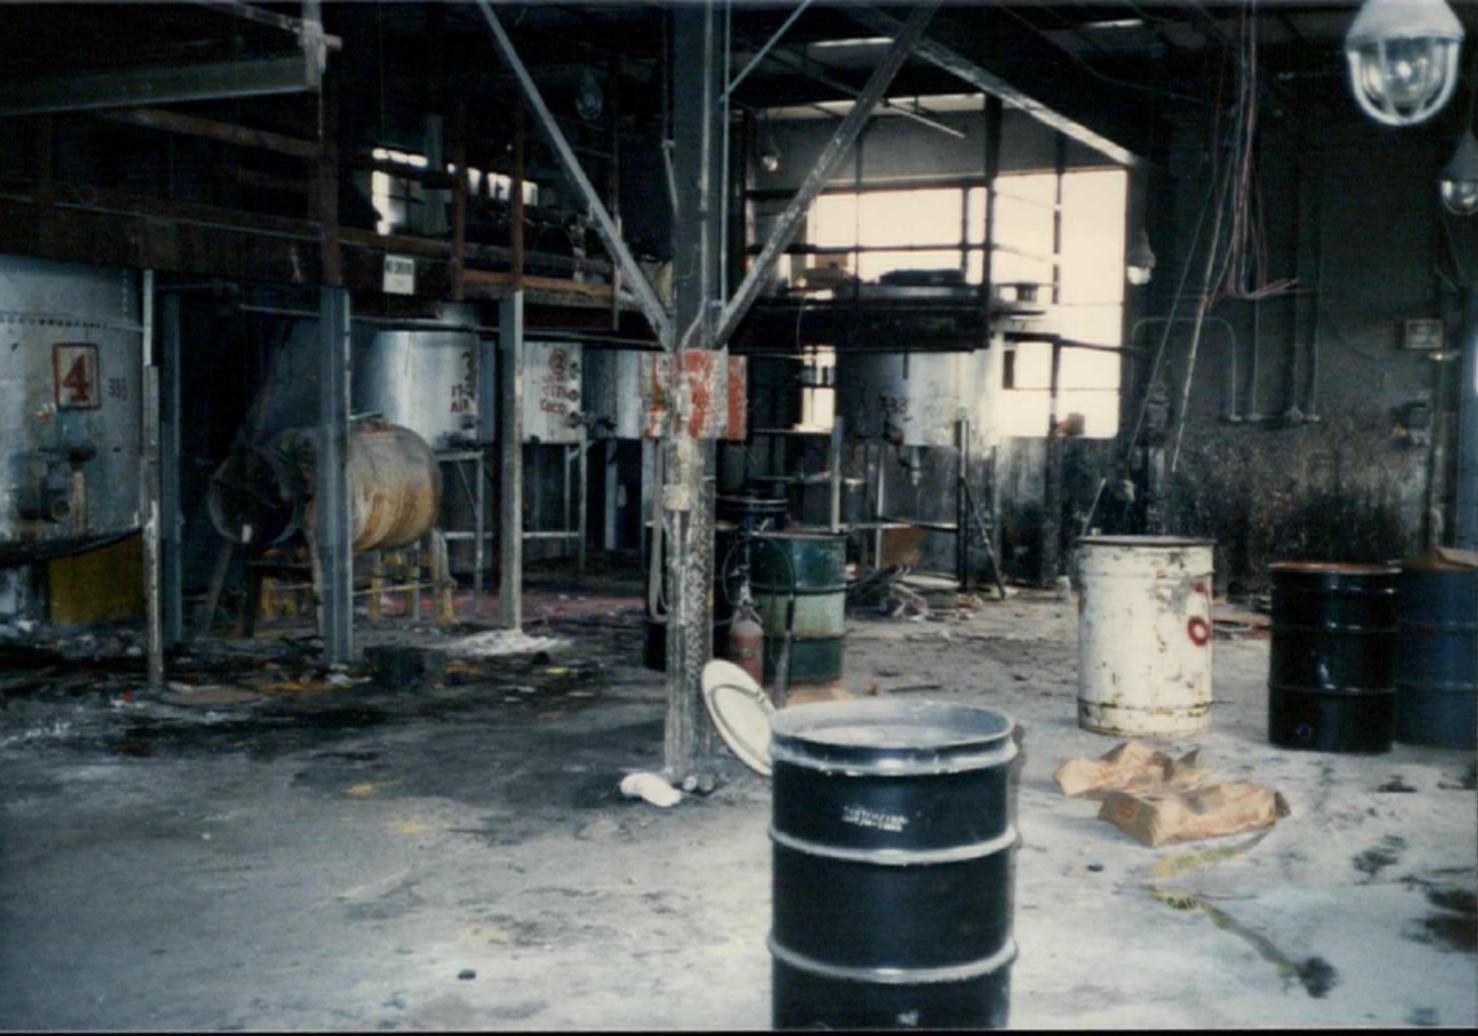
View of reactor room showing VATs
And miscellaneous drums with solids
inside.

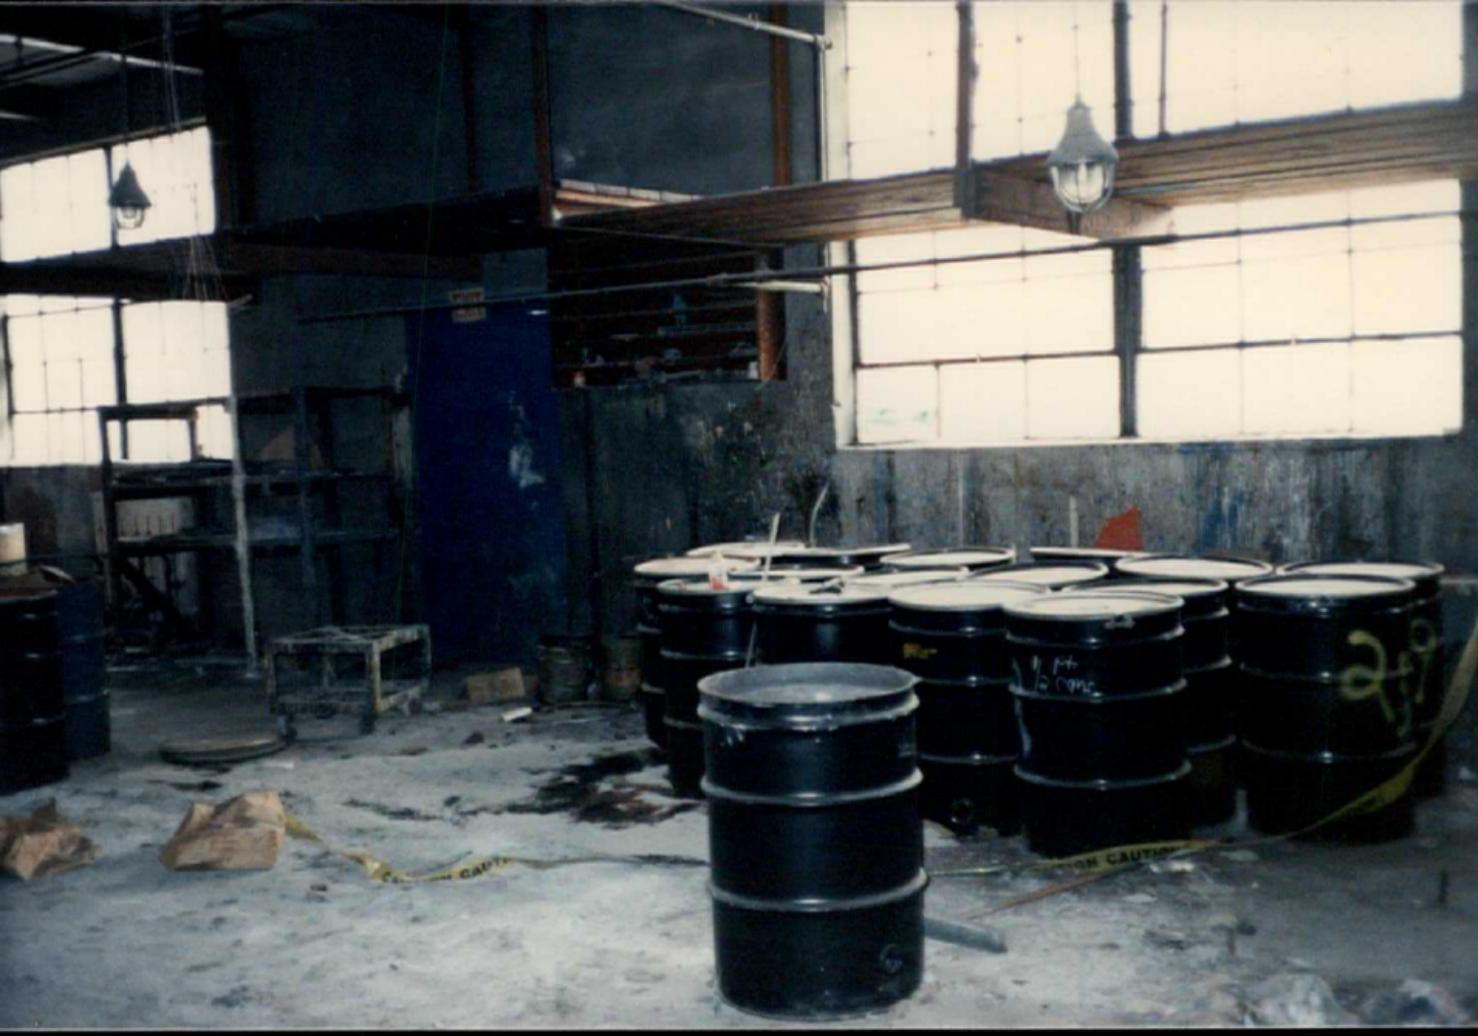
View of north side of reactor
room with 14 drums labeled paint
sludge.

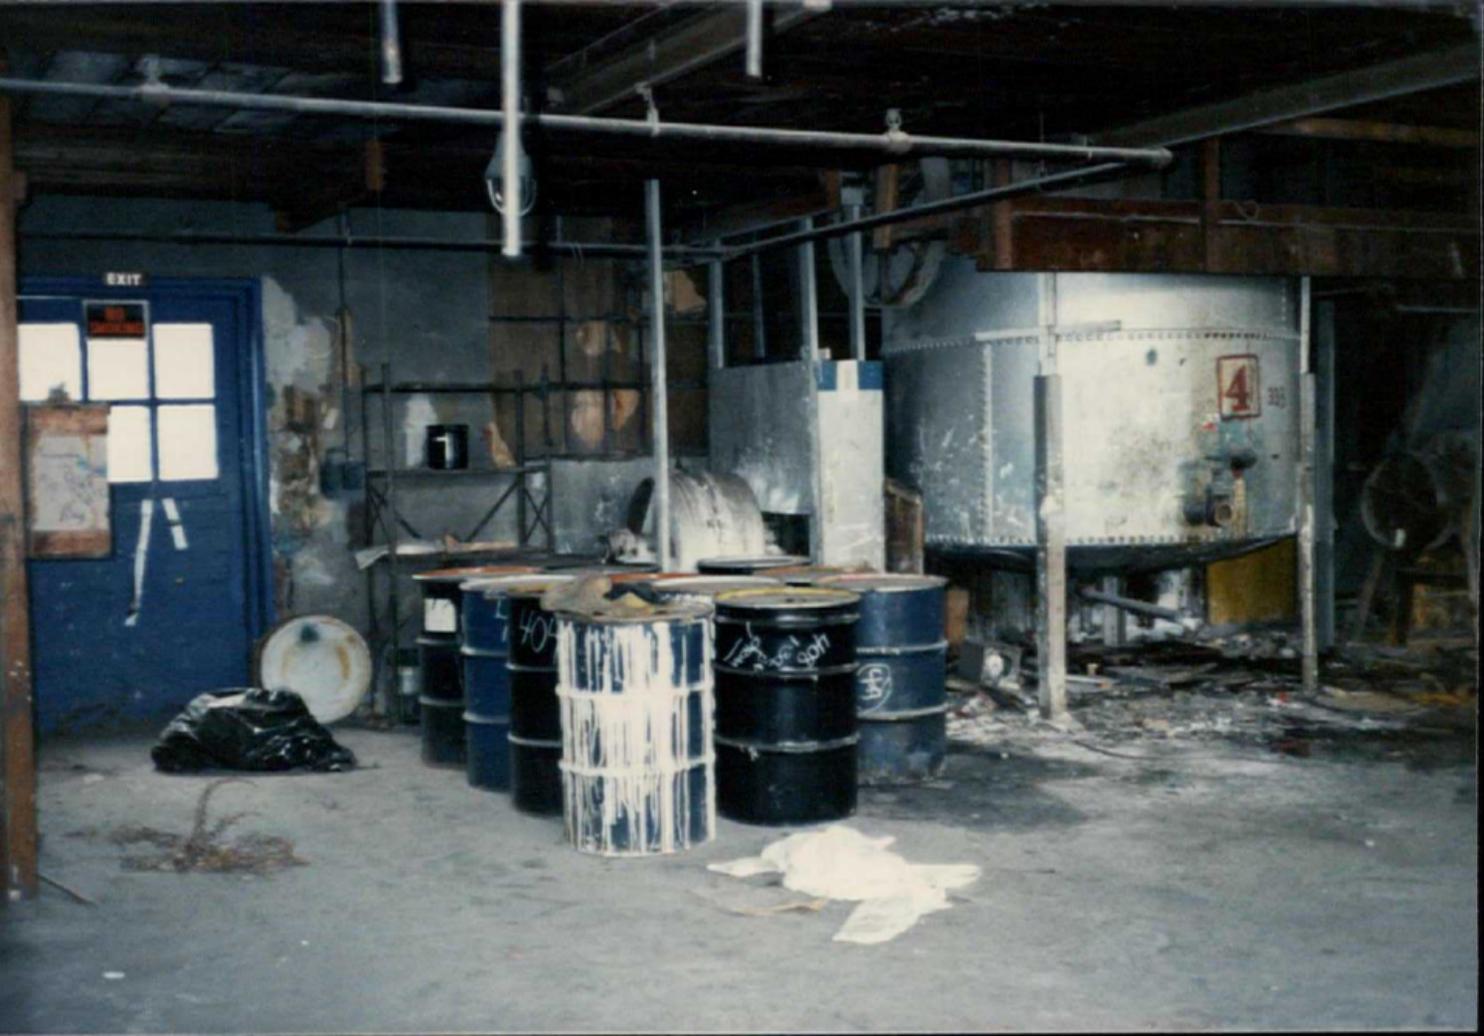
View of 12 drums in reactor room, drums were labeled "waste paint sludge".

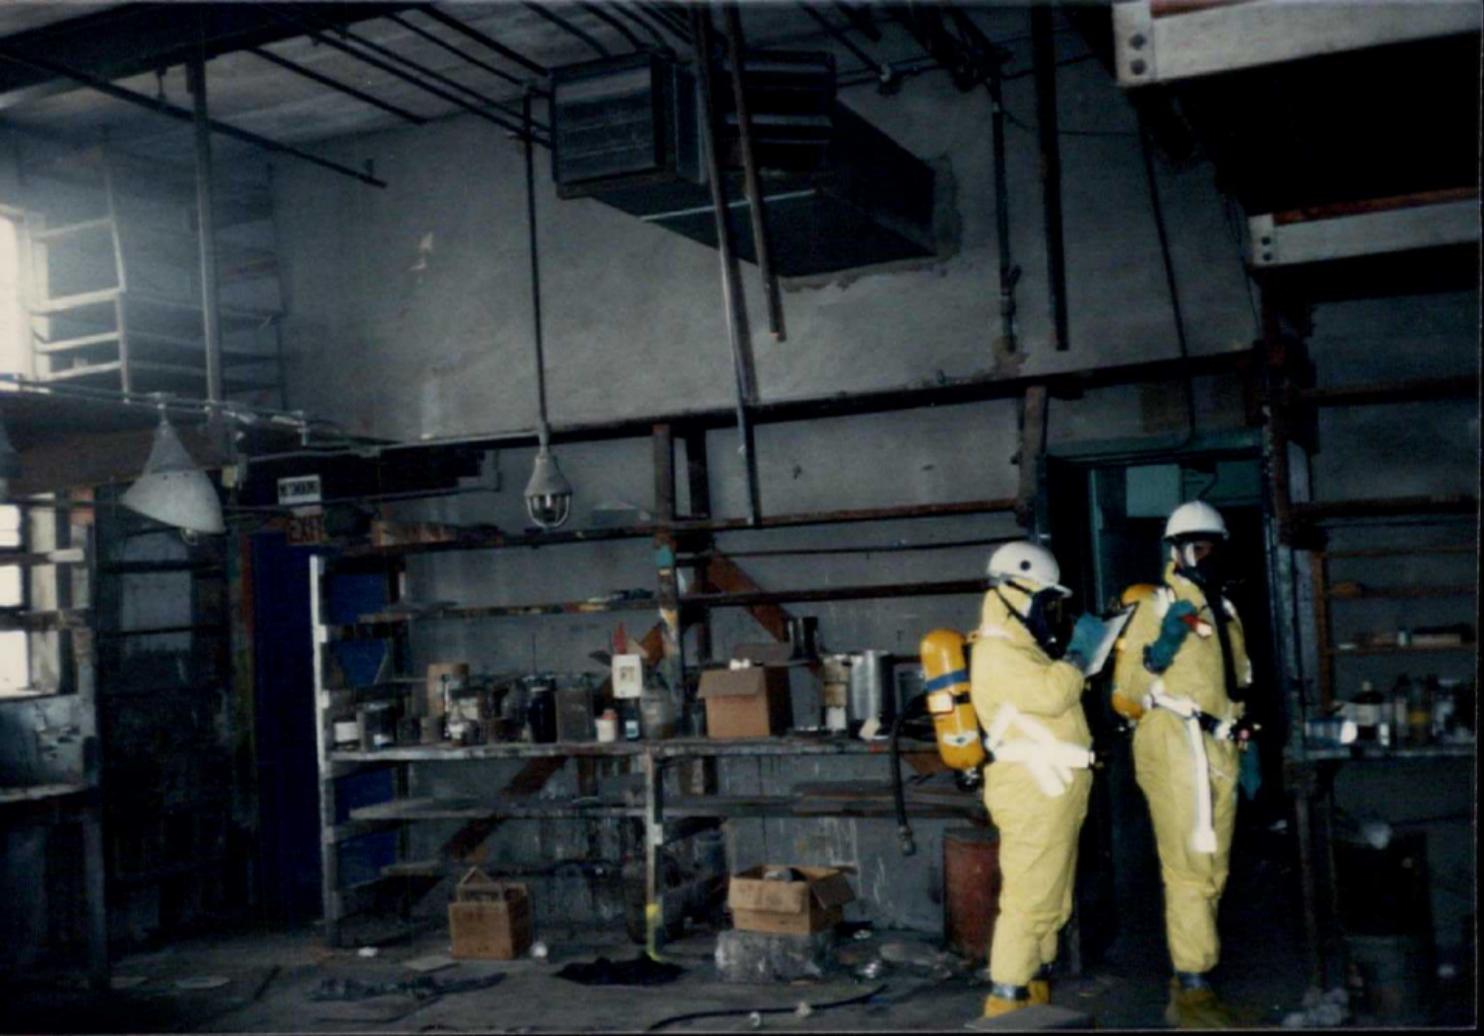
Full view of north lab bench
note carboy below bench at center.

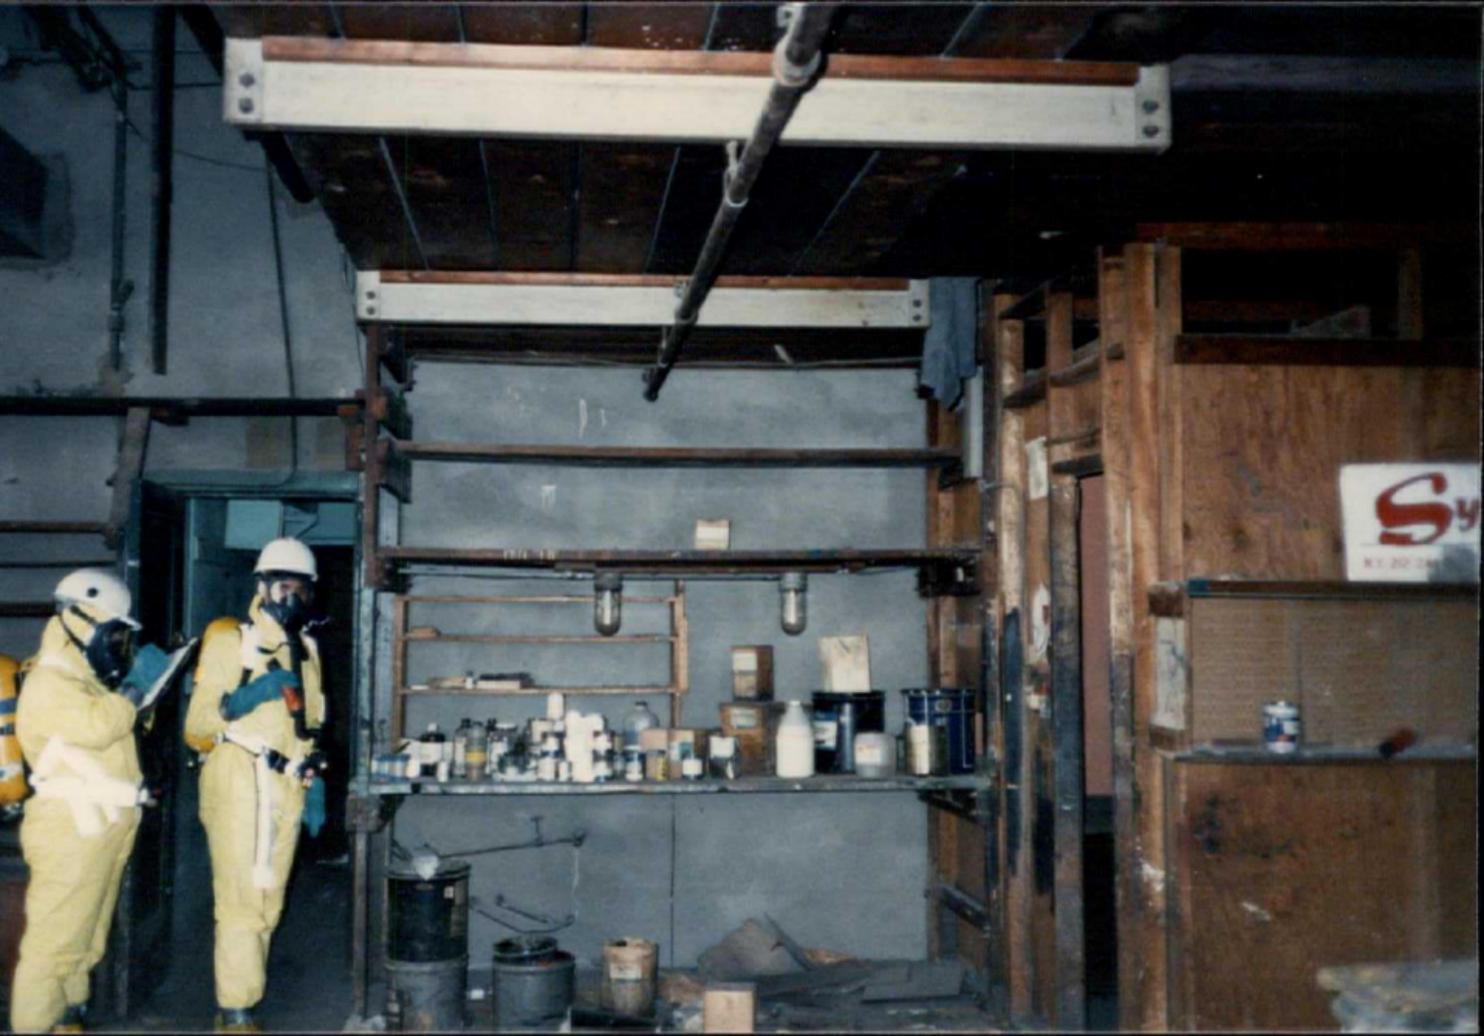
Full view of south lab bench
note crated poison at center.

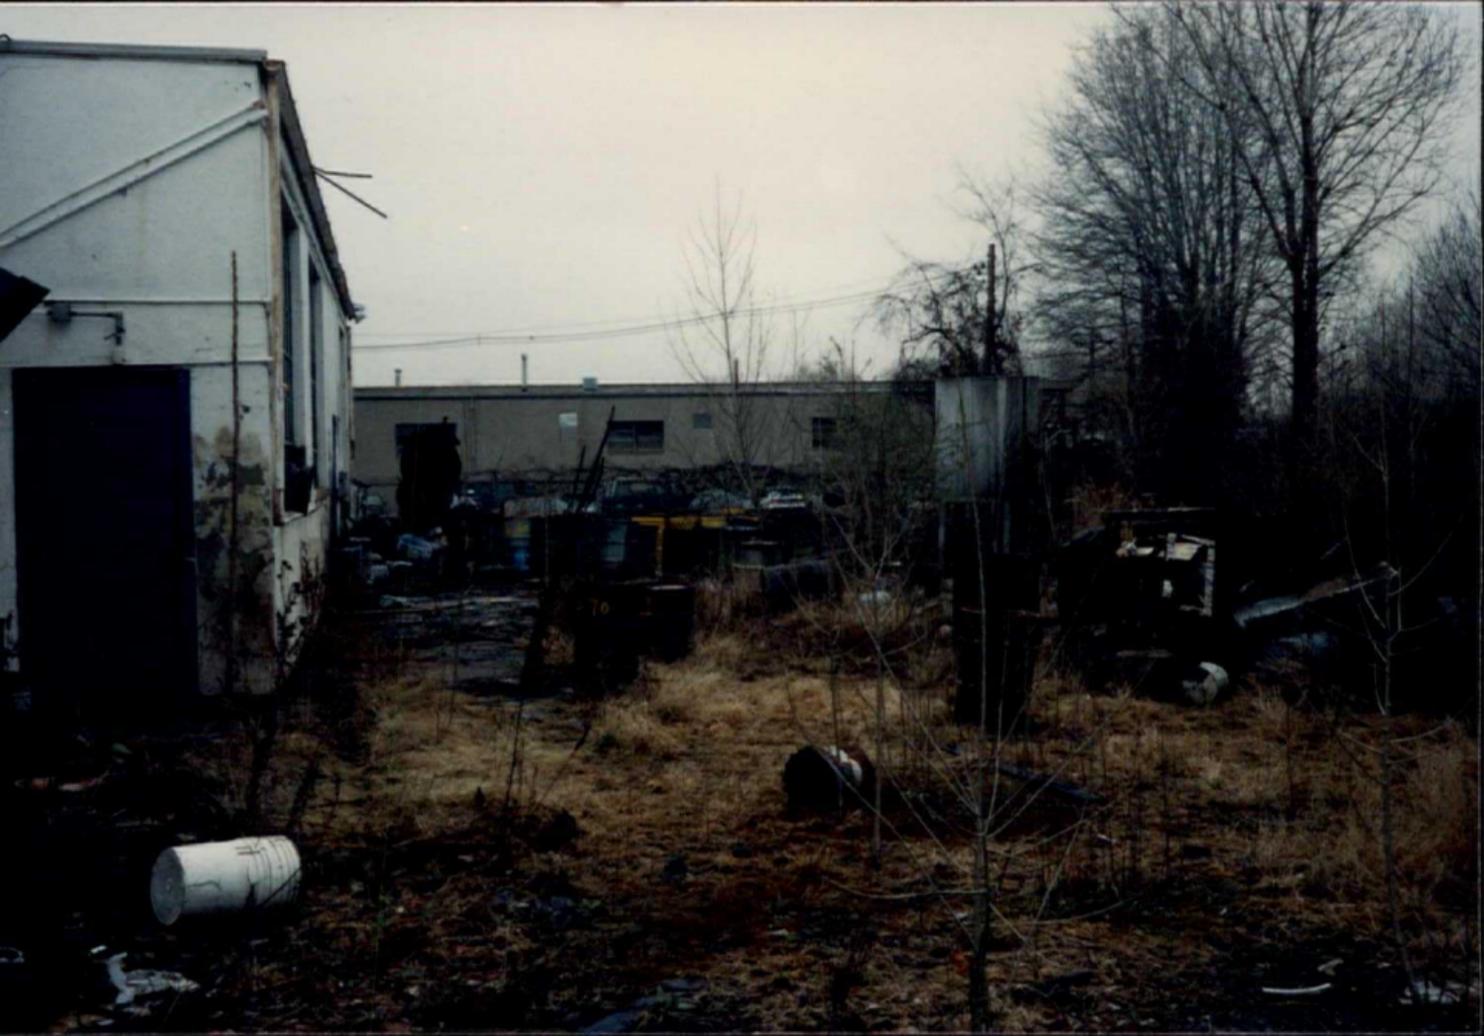
View look west of rear area
of site, note discolored soil.

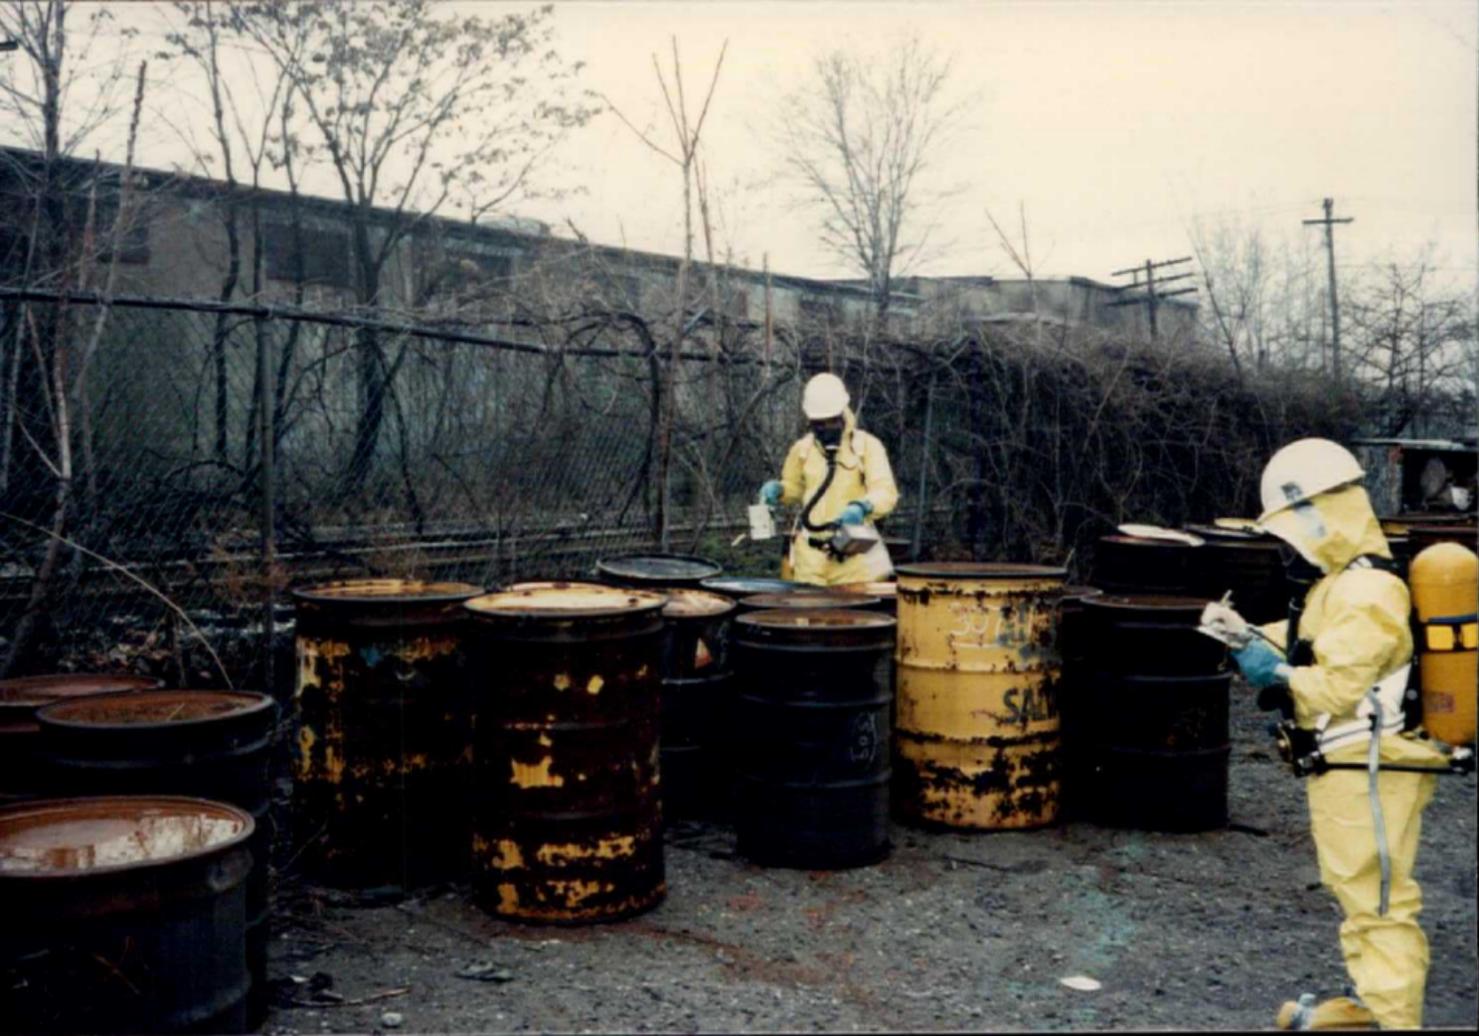
TAT using explosimeter & radiation meter
to screen drums. Note triangular
warning label indicating that drums

are an explosion hazard when
empty.

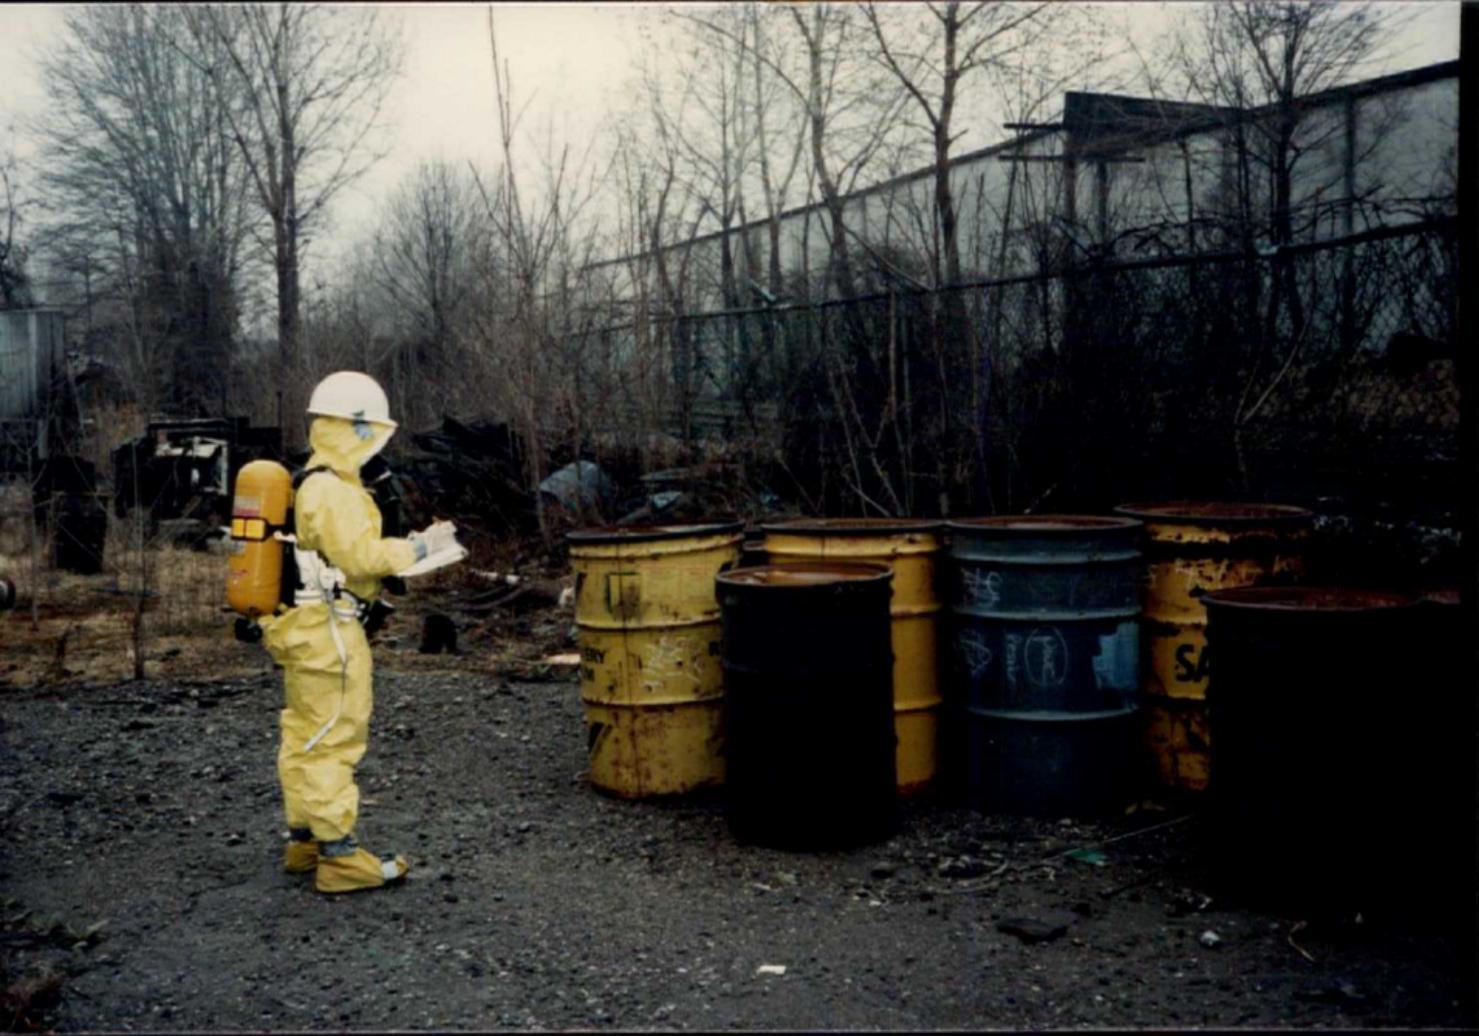
TAT taking notes on location of
drums. Note ~~drums~~ some drums
were labeled with hazardous waste

labels, but no information was
found on these labels.

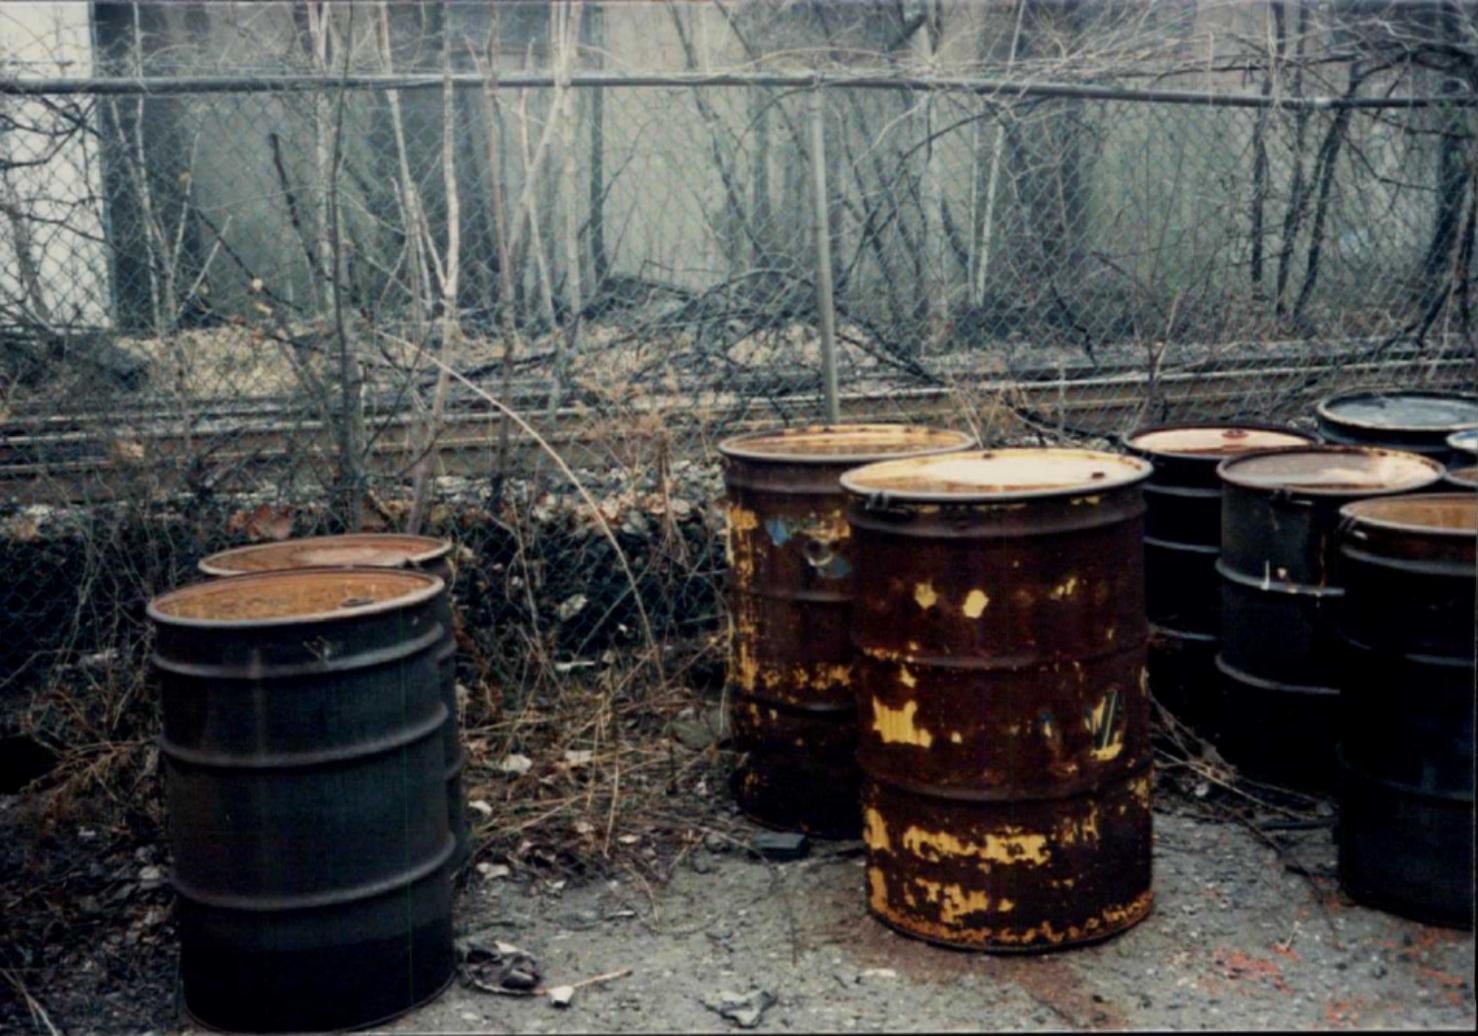
View of yellow rusted salvage drum
~~and~~ in front, and black drum, in
back which gave elevated OVA readings.

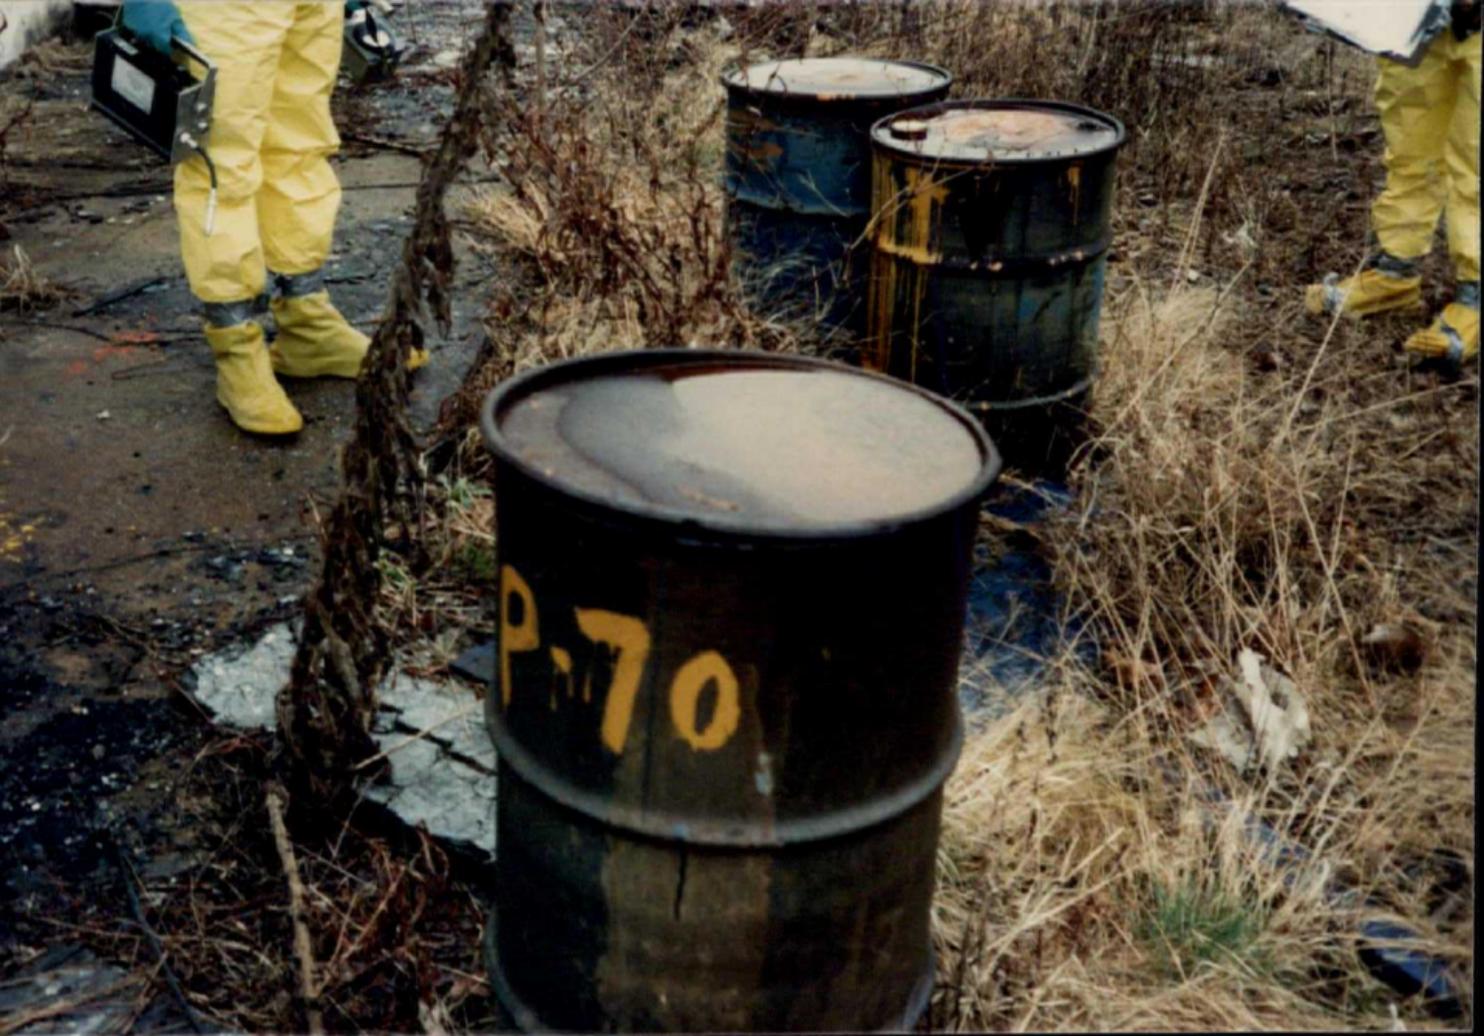
View of drum which was not sealed.
Elevated OVA readings were obtained
from the opening in this drum.

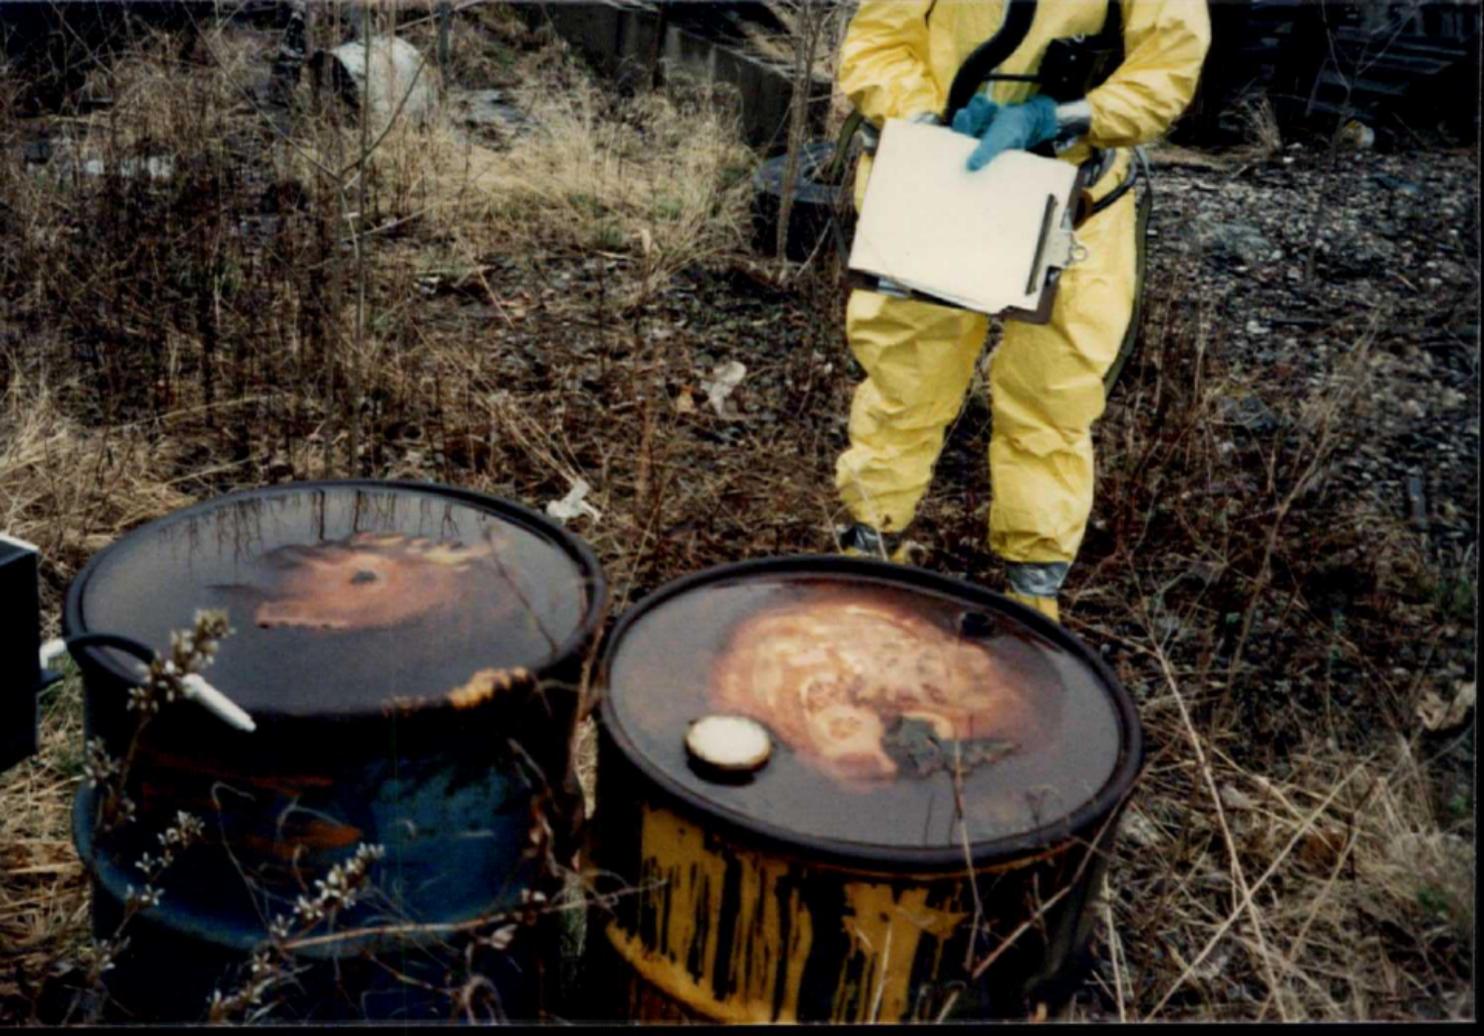
Two more drums with opened sides,
elevated reading on the OVA were
found in these openings.
